**US Army Corps
of Engineers®**
Engineer Research and
Development Center

Navigation Systems Research Program

Detection and Evaluation of Scour Protection for Navigation Dams

August 2008

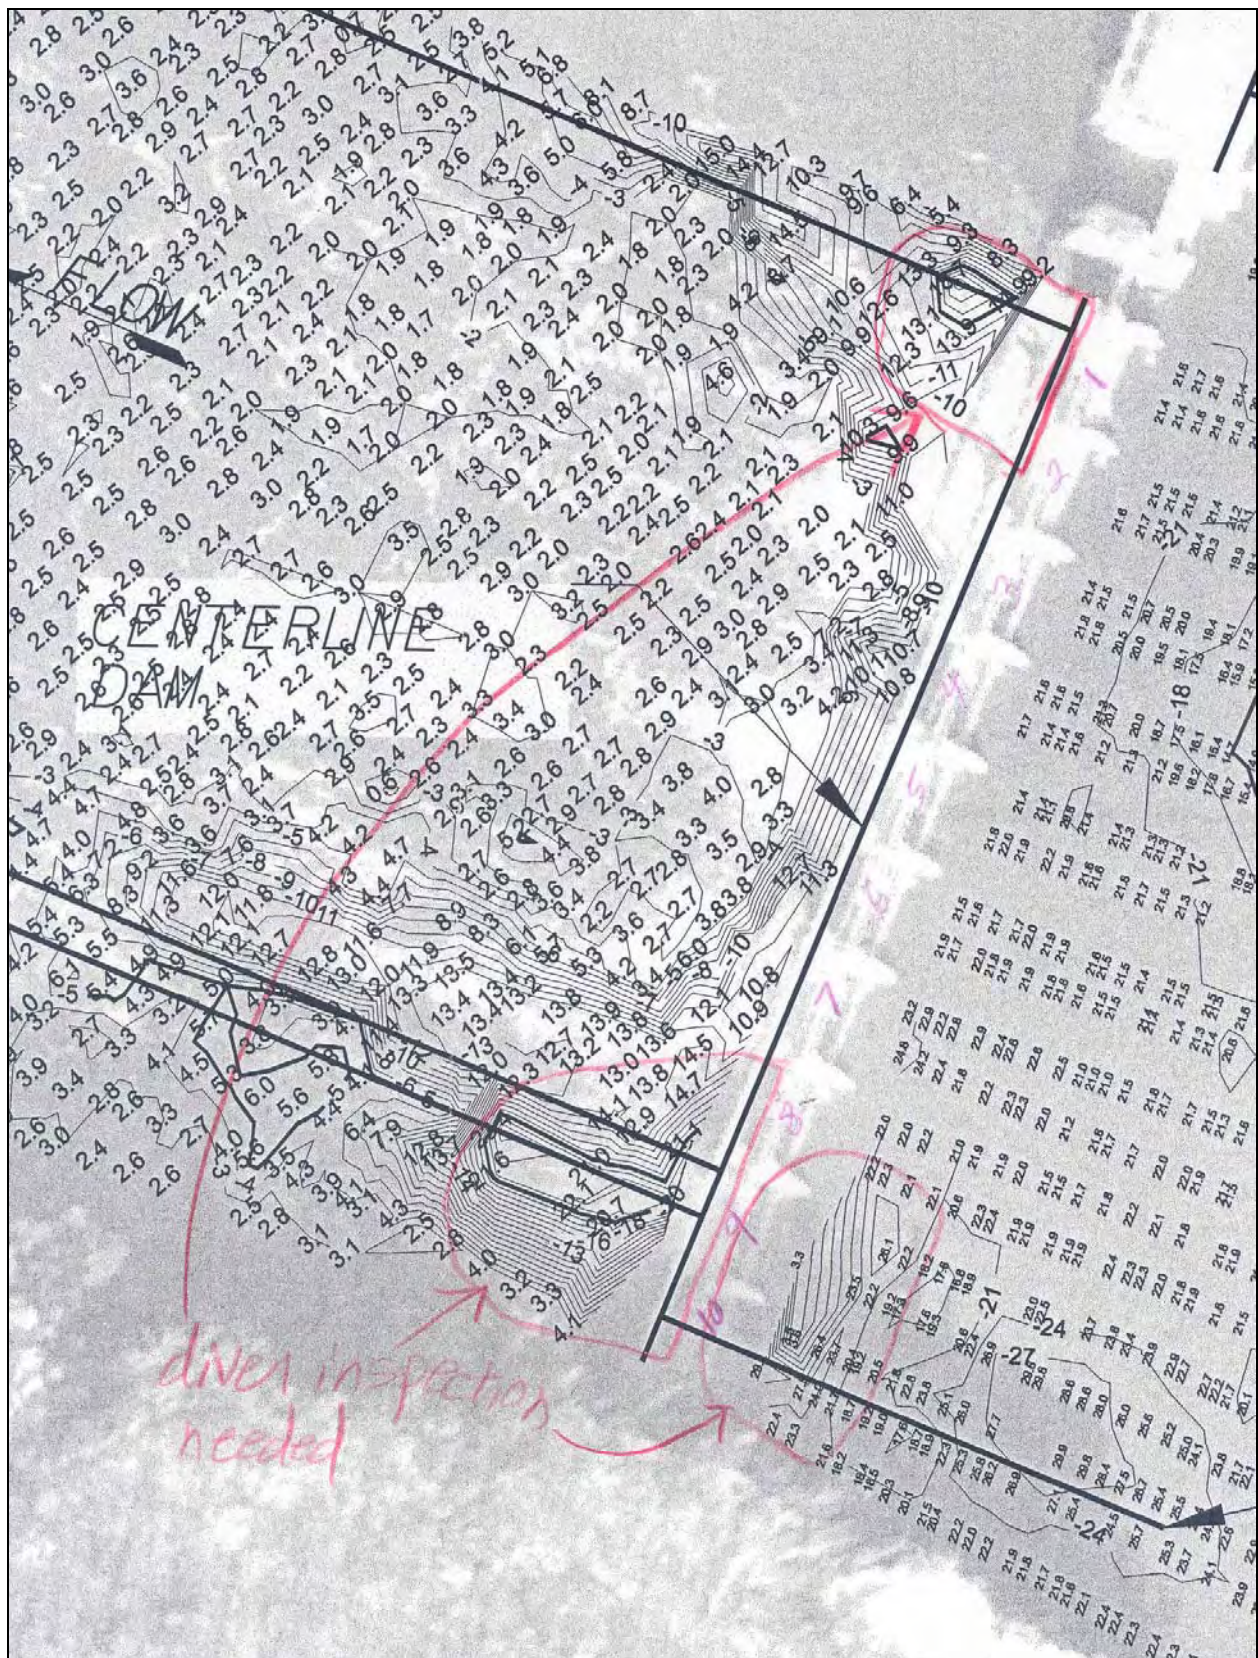
Figure 12. 2005 sounding data for Starved Rock Dam, flow is from right to left.

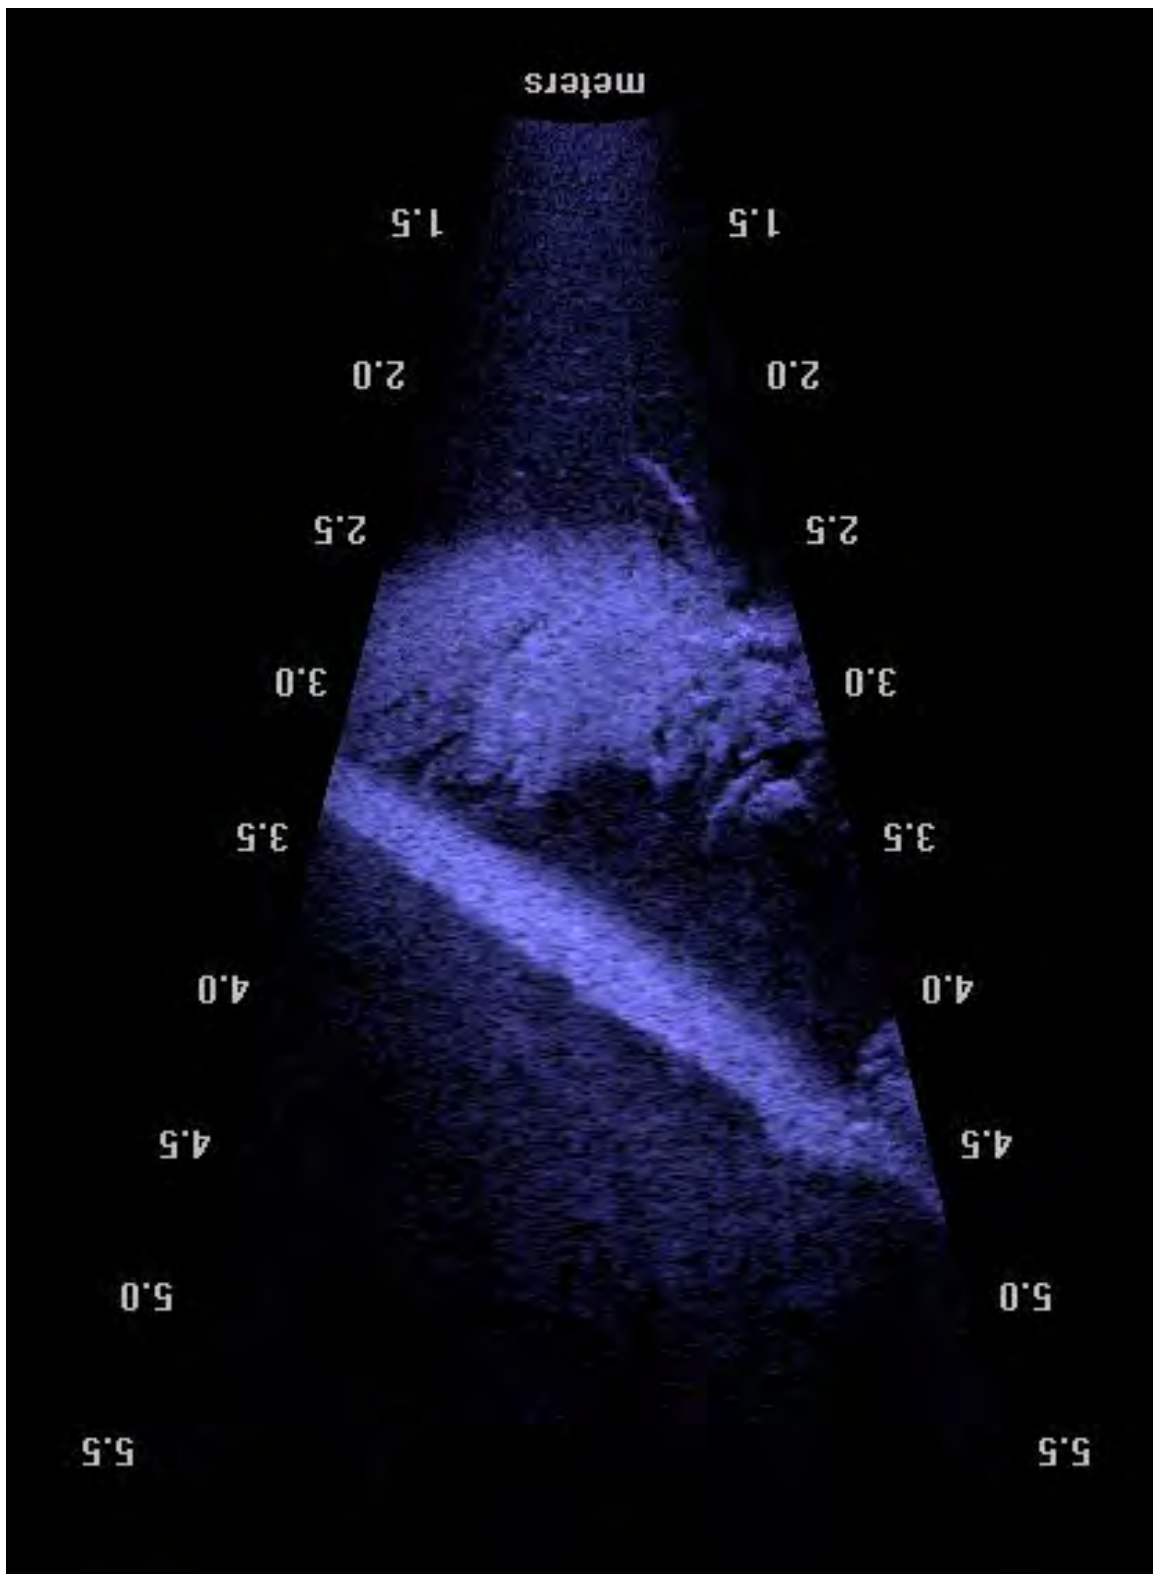
Figure 24. Area below gate bay 10.
